**ROOFS**  
A Study of Fatal  
Accidents at Work

## AN ANALYSIS OF ROOF MAINTENANCE

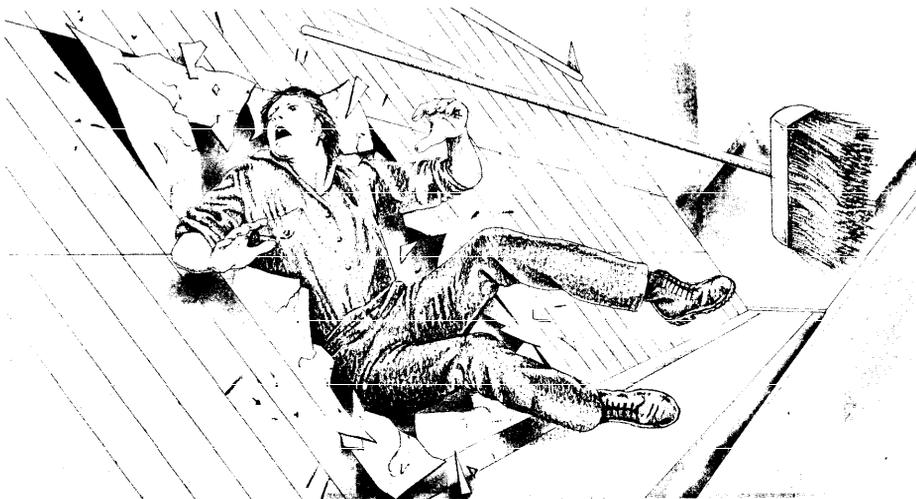
Man cleaning valley gutters on asbestos cement sheet roof. Broom, spade and bucket in evidence. Stumbles and falls through roof sheets.

'An apprentice plumber fell 9.1 m (30 ft) through an asbestos cement sheet roof of a warehouse while cleaning the valley gutters. His mate who fell with him was seriously injured. The work area along the edge of the gutter was not covered. There was a total lack of planning before the job was started.'

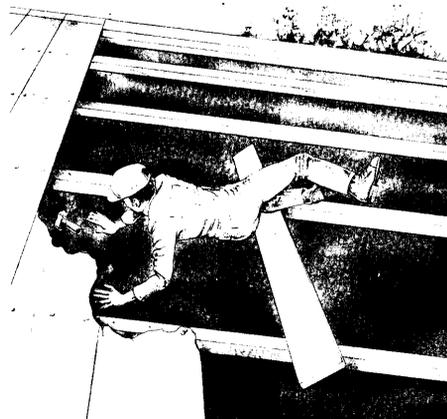
Stripping asbestos cement sheet roof of a factory. Man falls from a single narrow (1 1/2") roof board through a roof sheet.

'The working director of a roofing company fell 10.7m (35 ft) while stripping and re-sheeting the asbestos cement roof of a factory. A single timber staging slipped and the director lost his balance. There was an adequate number of stagings available but they had been left at ground level.'

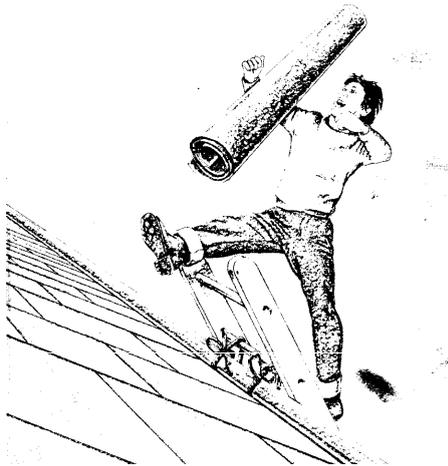
Man carrying a roll of roof felt on his shoulder up a ladder to roof level. Loses control of roll, man and materials fall to ground.

dangers not only of not securing ladders but also of trying to carry cumbersome materials on those that are secured.

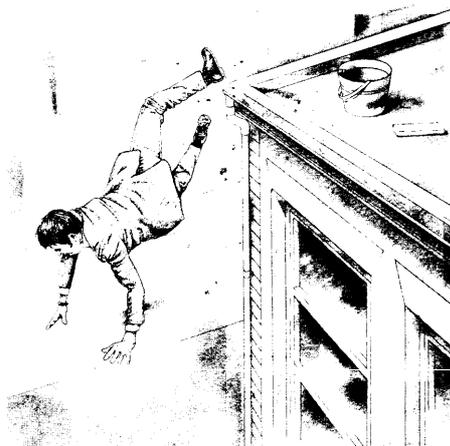
Re-covering flat roof with new felt. Man kneeling examining partly completed work near roof edge, and falls off to the ground.

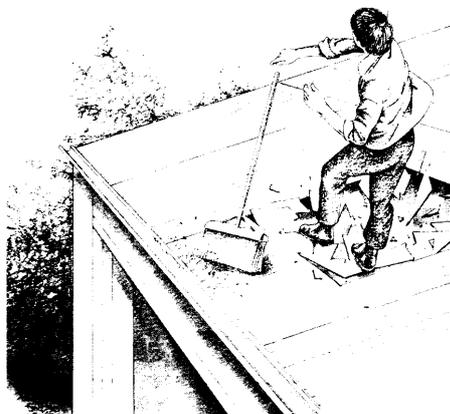
Man walking down sloping asbestos cement sheet roof sweeping debris with a broom. Farm building. Man falls through plastic skylight.

63 A farmer fell through a plastic skylight while repairing the asbestos roof of a shippon. Neither a cat ladder nor crawling boards were used
